SVX Sun Visor Fix

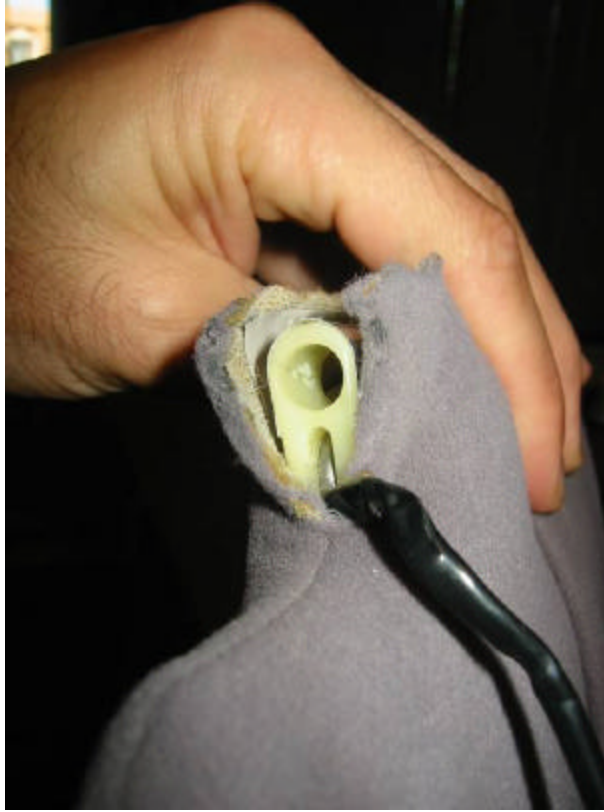
This visor stopped working one day when I attempted to pull it down, and I hear a very loud "pop". After that, it didn't stay up at all. When I cut open the fabric, I found that one of the plastic support loops had snapped on one side.

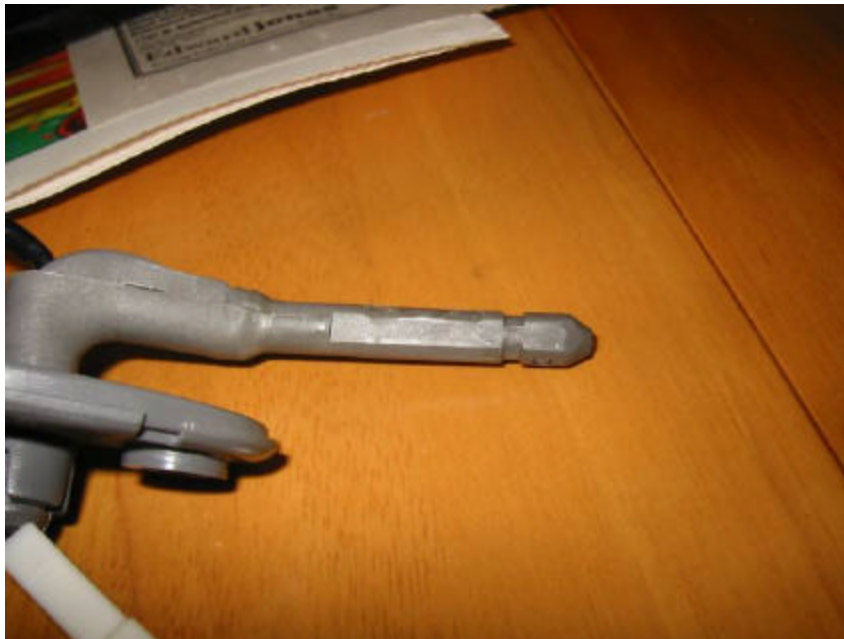
The plastic already was glued shut with superglue and didn't hold.

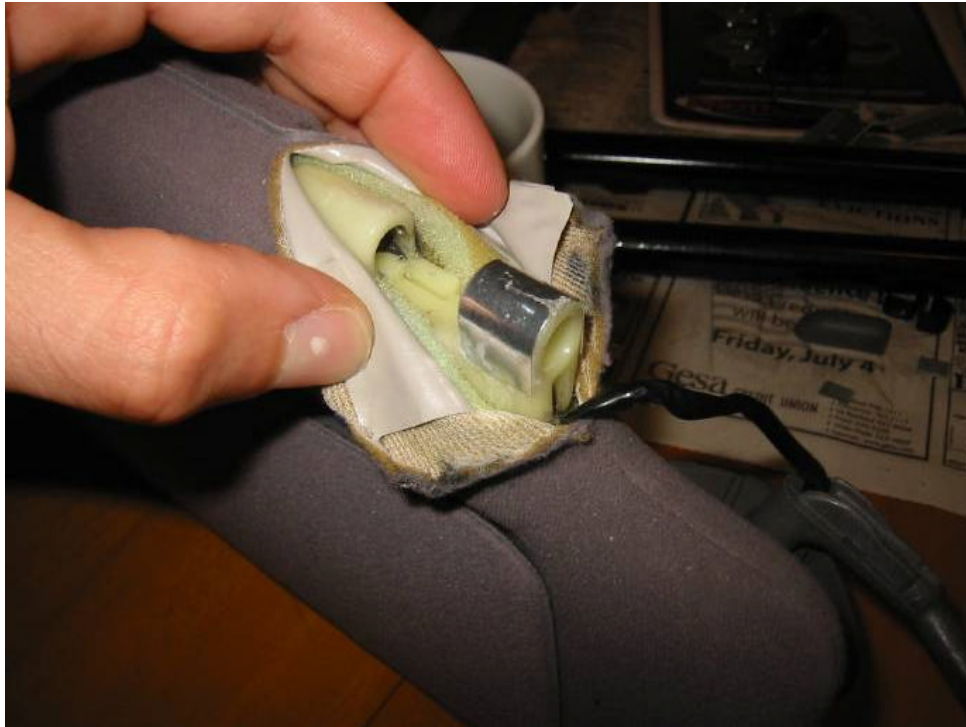
Note the wear marks on the arm which contributes to the droop of the visor.

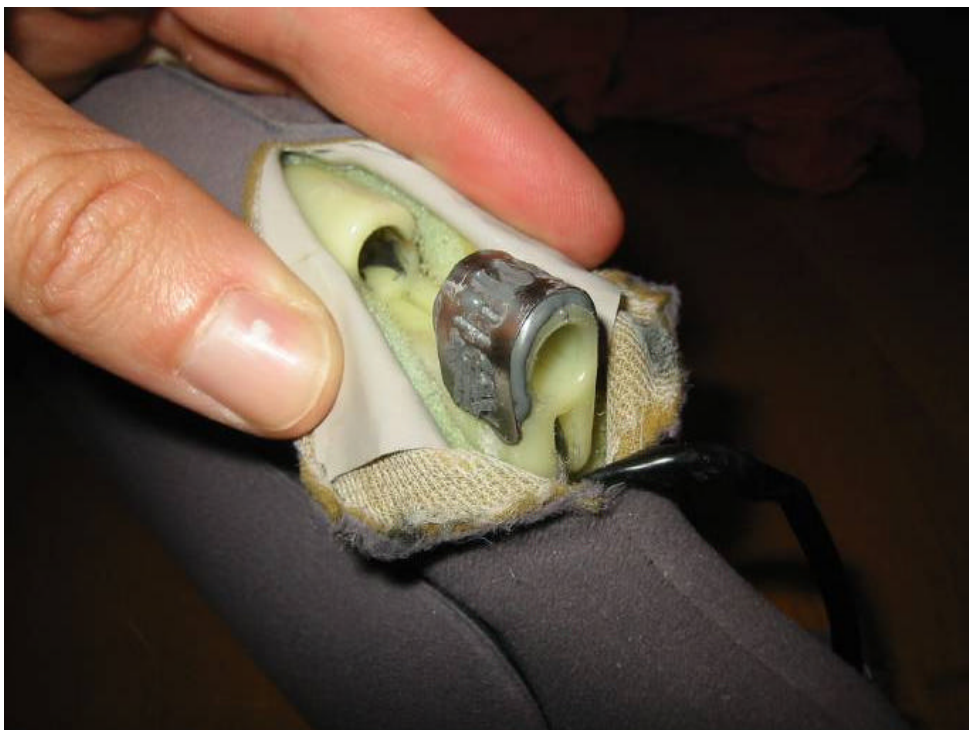
My first attempt to fix the break was with superglue and a strip of aluminum can. I roughened the visor plastic and the strip with emery cloth, and the superglue held well enough, but the Al snapped the first time I tried to rotate the visor down. When that happened, I realized that the plastic loop in the visor supports a very large stress, and I was no longer surprised that the plastic eventually failed.
