1992-1997 Subaru SVX TPS Investigation and Possible Homebrew Repair Procedure (ver prelim 12/16)

Prepared by gwynethh and friends 2016

This document discusses our investigation of SVX and other Subaru Throttle Position Sensors with an eye out to working up a replacement for the SVX ones that are No Longer Available from Subaru.

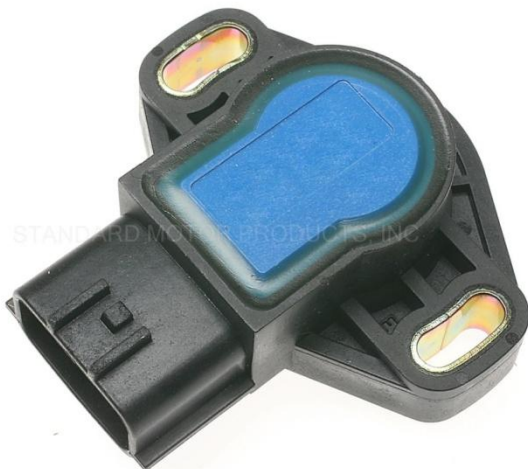
THROTTLE POSITION SENSOR SERA483-06 TPS FITS SUBARU SUZUKI 22633-AA110 TH237

We tried a generic Subaru one that looked plug end similar but the contact plate was very different and unusable. So no go on the 10\$ SERA483-06 TPS FITS SUBARU SUZUKI 22633-AA110 TH237. Internals were not photographed.

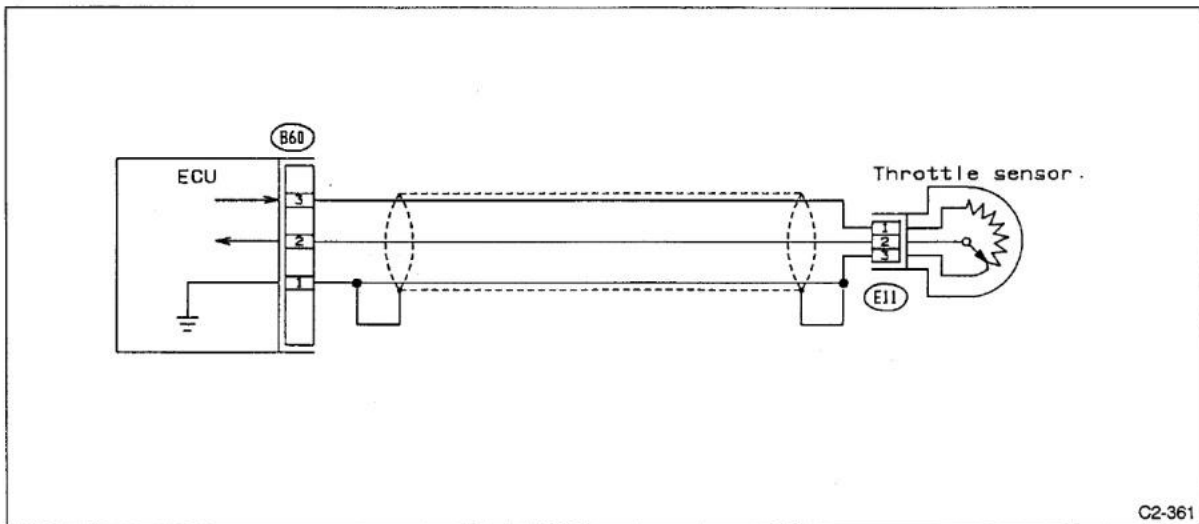
1. The TPS info in the 1992 SVX service manual appears to be incorrect on the expected closed resistance of 10-12K Ω (but INCREASING as opened). Open resistance test of 5K Ω appears to be close.
2. The used SVX TPS we tested had a closed resistance of about 100 Ω and an open resistance of 5.8K Ω and a gap in the readings.
3. The used Impreza TPS has a closed resistance of 60 Ω and open resistance of 5.3K Ω . The Impreza TPS requires a different mating plug due to a lip inside the socket with no gap in the readings.
4. The new generic TPS had closed and open resistances that are way off.

Some photos of the disassembled SVX TPS and the schematic.

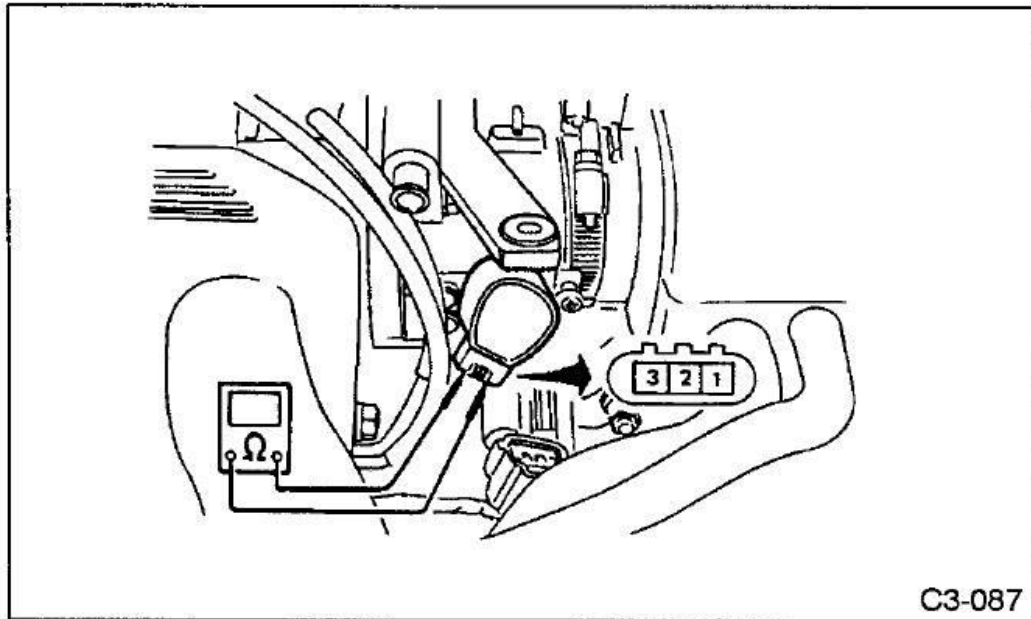
Fig. 83

and the FSM page on trouble shooting that appears to be total baloney with wrong resistances. We found 5.5K Ω on pins 1 to 3 and ~200 Ω between pin 2 and 1 (or 3 depending how you interpret the Subaru manual figure).

4) Measure resistance between terminals while slowly opening throttle valve from the "close" position.

Terminal/Specified resistance

No. 2 — No. 3/10 — 12 k Ω [Fully close]

/3 — 5 k Ω [Fully open]

Ensure resistance increases in response to throttle valve opening.

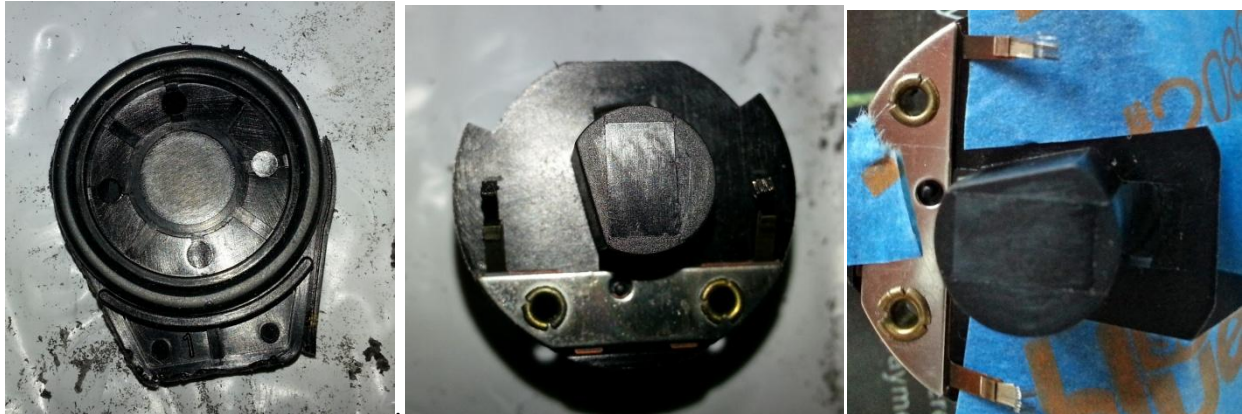
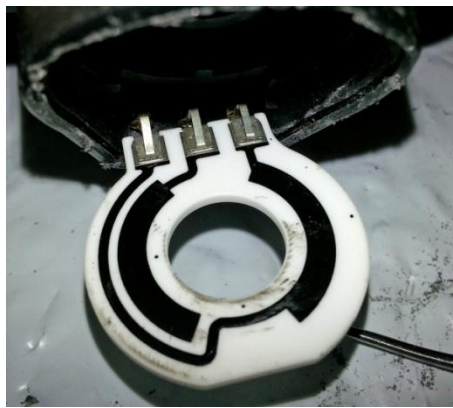
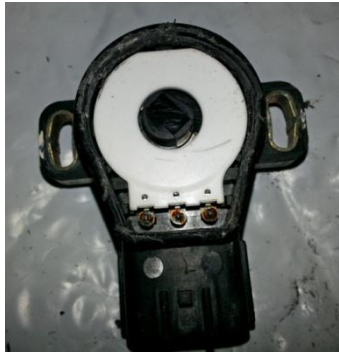
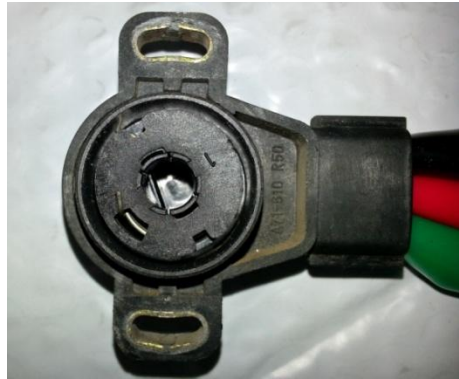
Images of the SVX TPS internals and some Impreza photos

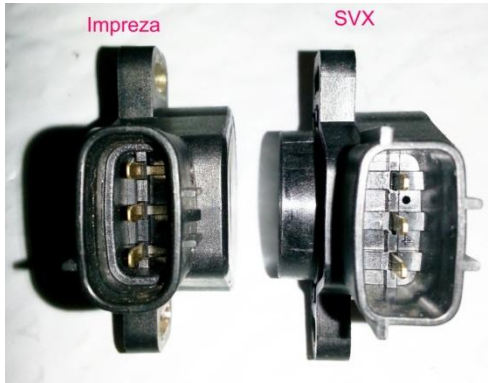
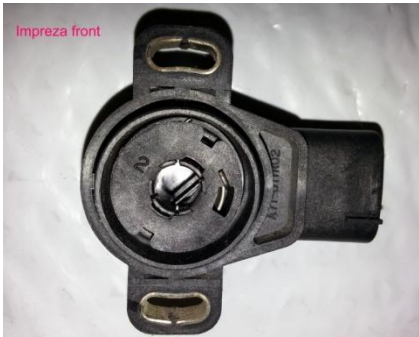
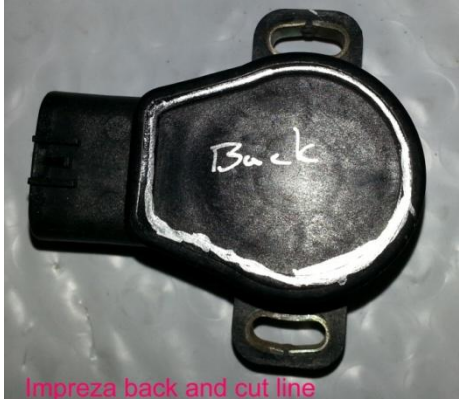
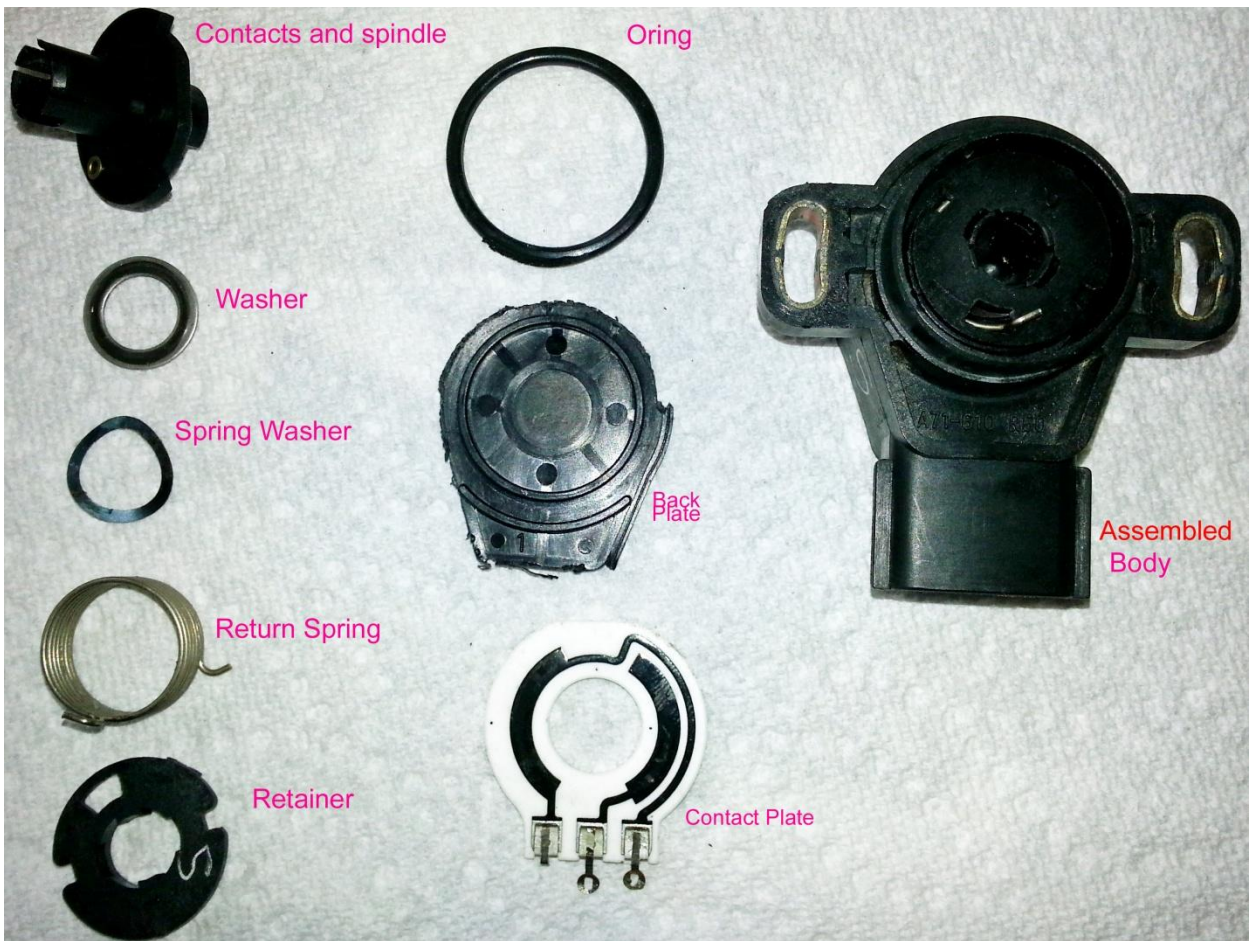
Impreza TPS photos below

All parts. (Note the eyelet we broke on the bad SVX contact plate). The assembled view is of the Impreza TPS. On that TPS the spring hook is on the lower part of the retainer.

After doing the initial photos and resistance checks we opened the Impreza TPS by grinding out the sealing epoxy (?) between the back cover and body.

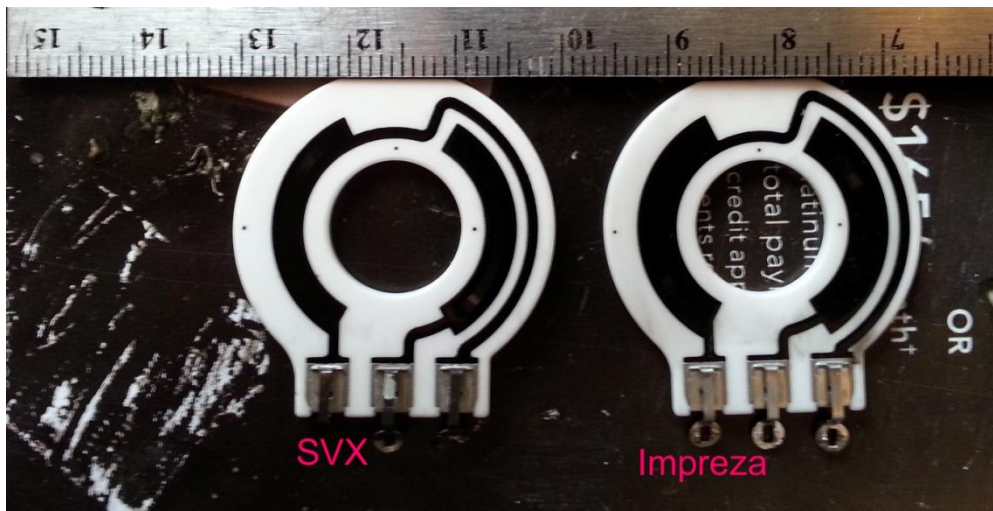
Photo of Impreza and SVX contact plates

The Impreza one appears to have wider contact traces as the SVX one. Sadly the Impreza TPS is NLA in the USA.

The cause of failure seems to be wear of the deposited carbon off of the contact plate.

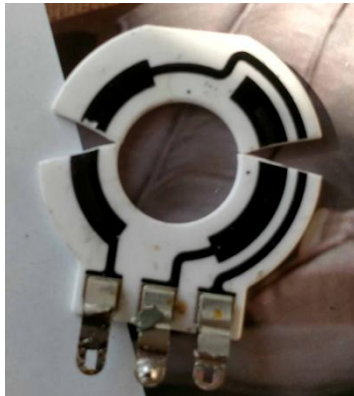
We opened a refurbished A71-000 B50 and it MAY have had a proper ceramic contact plate but we broke it getting it disassembled. If you try one of these, start by grinding off the swaged head holding the operator arm to the shaft. Pop off the arm and the return spring. After that, remove the back plate per the method above or just destructively. Carefully pull out the nylon (?) part holding the contact fingers. The ceramic plate then can be de-soldered. The contact plate in this TPS is upside down from the SVX one. The resistances on the 3 pieces of the contact plate add up to about 5.5K ohms.

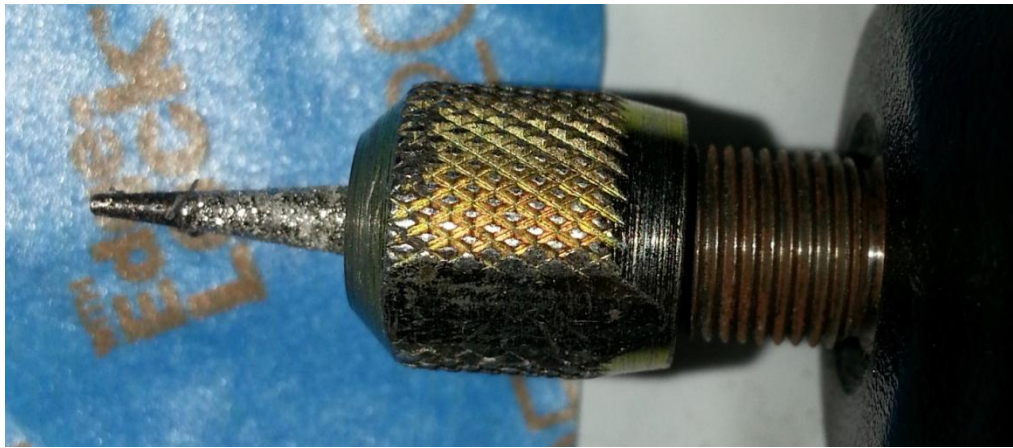
Tools needed: a Dremel or similar, cutting bits such as the below pointed bit and cutting wheels, some rubbing alcohol to clean the parts, some electrical contact cleaner, some Q-Tips and a maybe a can of compressed air used by techies for PC dust blowing. If you are really lucky and have one of those mini machine shop all in ones this work might be easier for you. Also a face mask 'cause who knows what is in that epoxy we'll be grinding out.

For reassembly some JB Weld or hot melt glue.

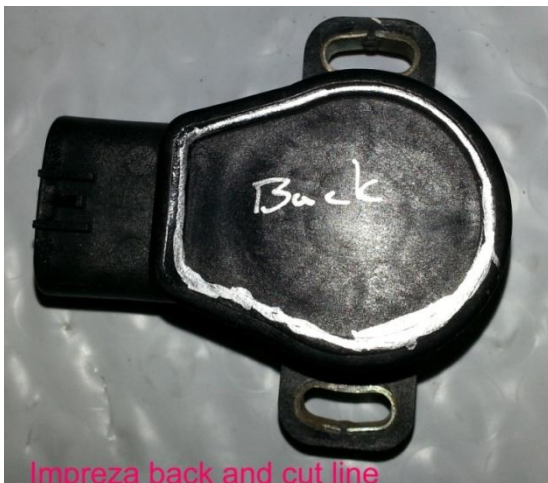
Identify the sealing plastic/epoxy between the back cover and body of the new TPS. Shown in silver on the donor TPS.

Start by cutting the straight runs of the sealing epoxy in shallow depth cuts. If your toothed wheel is small enough you can try making some cuts in the curved portion. The cuts photo was made on the

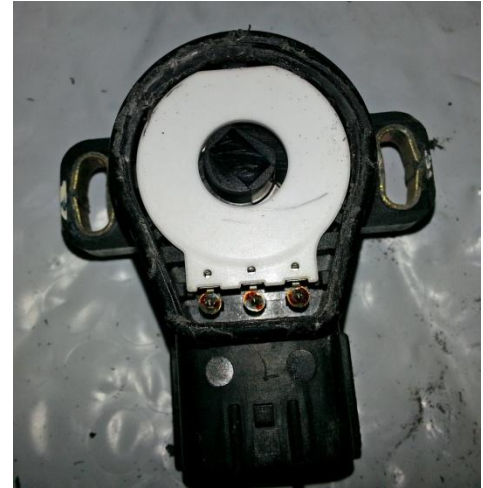
Make several shallow passes and pry out the back. This is what you should see. The contact plate you need to save from the donor TPS is that white thing. It snaps in place and is held in position by the three soldered contacts. Remove most of the solder with solder wick or a solder sucker. Be careful as the eyelets of the contact plate are fragile. If you are opening a Sentra A71-000 B50 the plate will be below the nylon plug and upside down too boot.

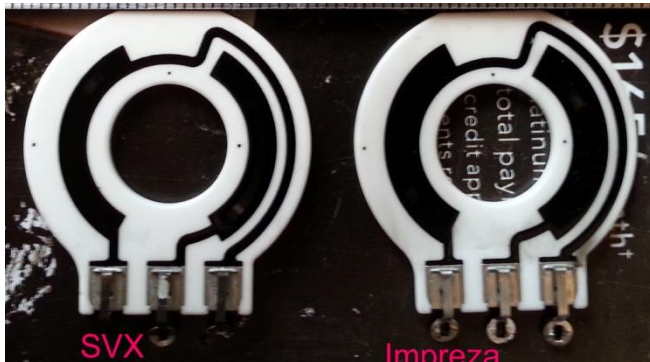
After removal the contact plate should look like this.

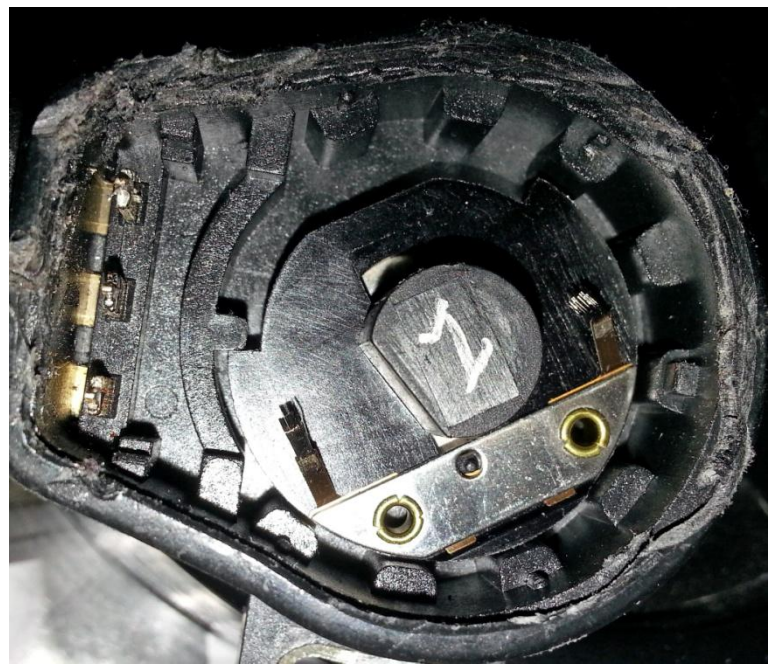
Under the contact plate you should see this. Note the contacts/wipers to the left and right of the center post/spindle.

The wipers should be looked at to see if the ones in the SVX body are usable or if you should also transplant the wiper rotor.

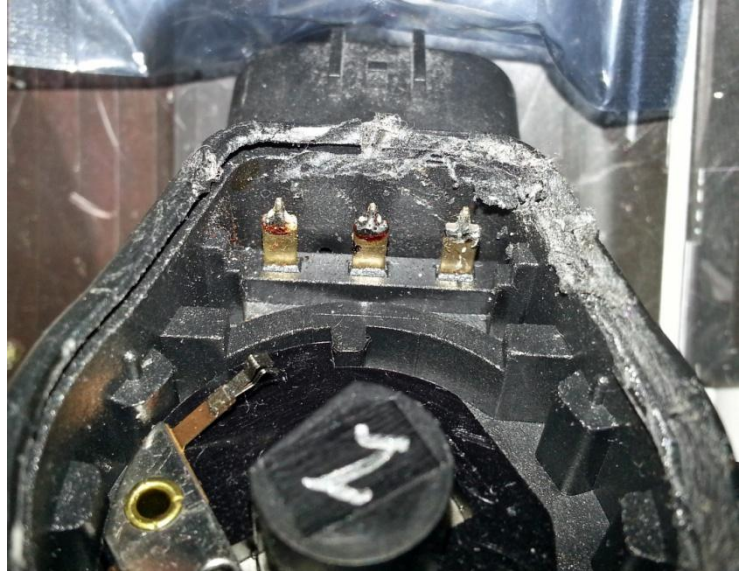
The solder pins will look like this before clean up.

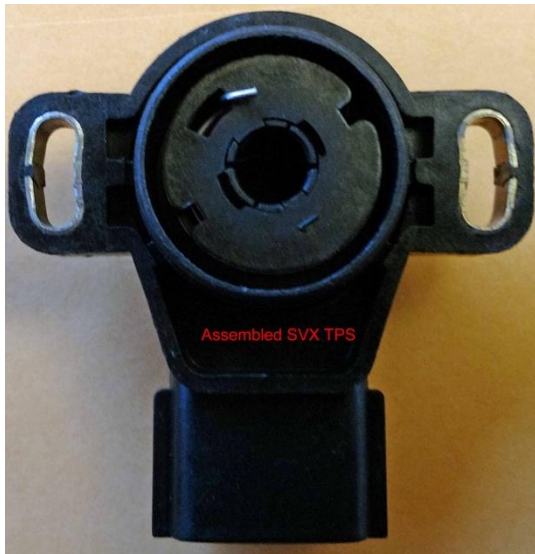
To reuse the spindle, unhook the spring from the front plate and pop the front plate off

Front plate and spring hook of a SVX TPS.

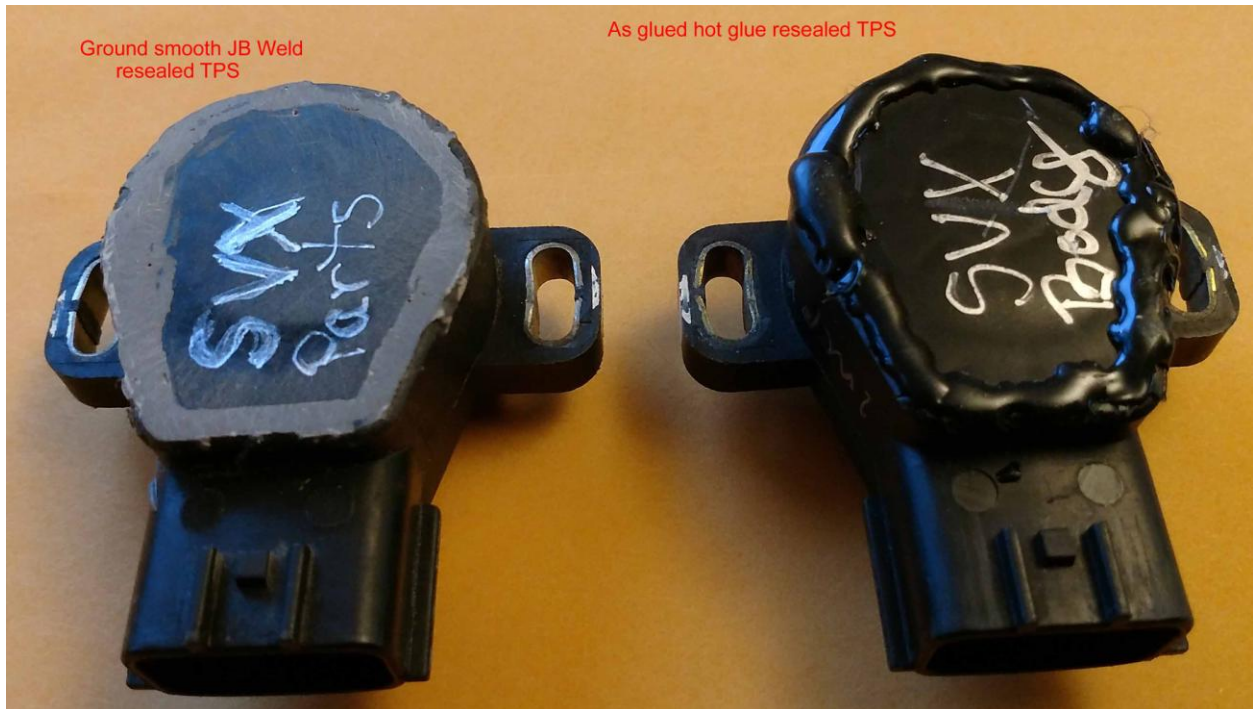
To reseal the TPS place the oring and back plate in position. Clamp the back plate down and re-glue/reseal the JB Weld or Hot gun glue. The JB Weld may be better in the hot engine compartment.

Both of these TPSii seemed to behave properly on the bench. The all SVX parts one (left) is from the Chinese refurb one we opened to investigate. The SVX body one was reassembled from a bad SVX one with an Impreza contact plate.
